# Monitoring Microstructural Evolution of Alloy 617 with Non-Linear Acoustics for Remaining Useful Life Prediction; Multiaxial Creep-Fatigue and Creep-Ratcheting

**Project Title:** Monitoring microstructural evolution of Alloy 617 with nonlinear acoustics for remaining useful life prediction; multiaxial creep-fatigue and creep-ratcheting 10-915

**Period:** January 1, 2010 through August 30, 2014

**Report Date:** October 30, 2014

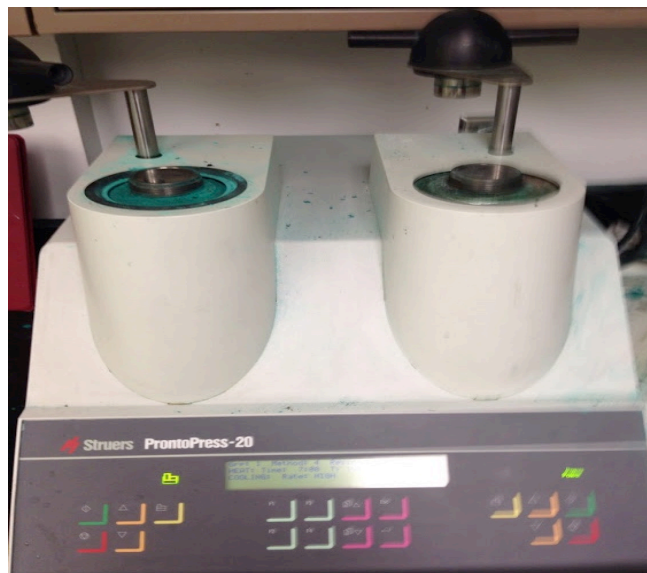
**Figure 2.3.1.2.** Struers ProntoPress-20 sample mounting machine

Once the sample has been cut from the tested specimen, it must be mounted in a fast-curing resin, allowing the sample to be ground, polished, etc. without having to touch the surface to be examined, which could potentially jeopardize the final results. The mechanism used to mount the samples is a ProntoPress-20 as seen in Figure 2.3.1.2, which melts the powdery resin material, then cures it by rapid cooling.

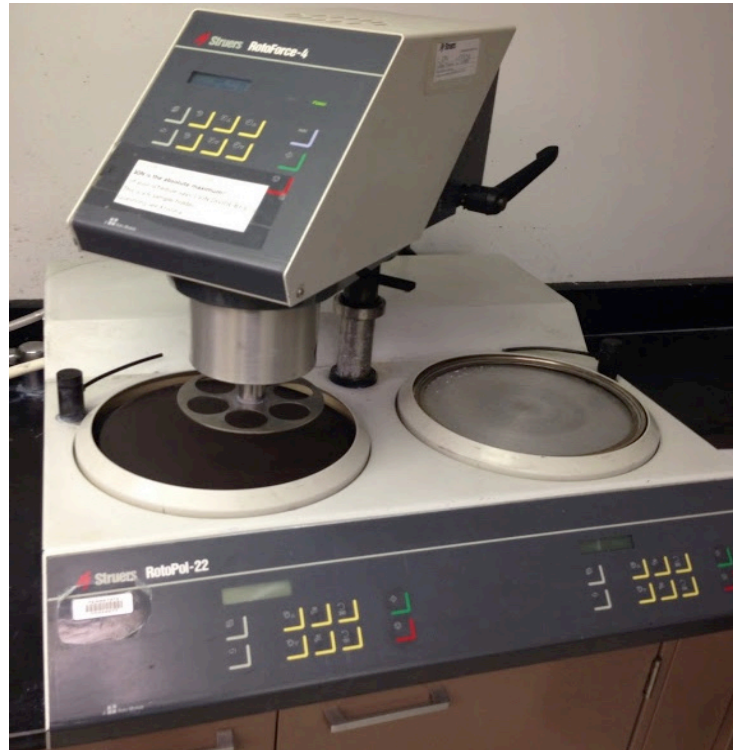
**Figure 2.3.1.4. Struers RotoPol-22**

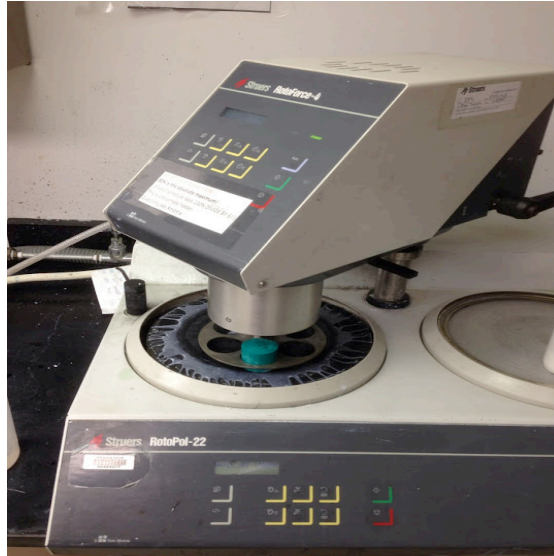
**Figure 2.3.1.5.** Alloy 617 sample being polished

Following sample grinding is sample polishing. Each sample undergoes three rounds of polishing, two of which are using the same polishing materials. The machine used for polishing is the same used for grinding. However, for polishing, a mechanical sample holder is used which, in addition to the spinning polishing pad, also spins and applies a user-specified amount of force to the sample being polished. Figure 2.3.1.5 shows a sample undergoing the process of polishing. It is worth noting that for polishing, only one sample is prepared at a time.

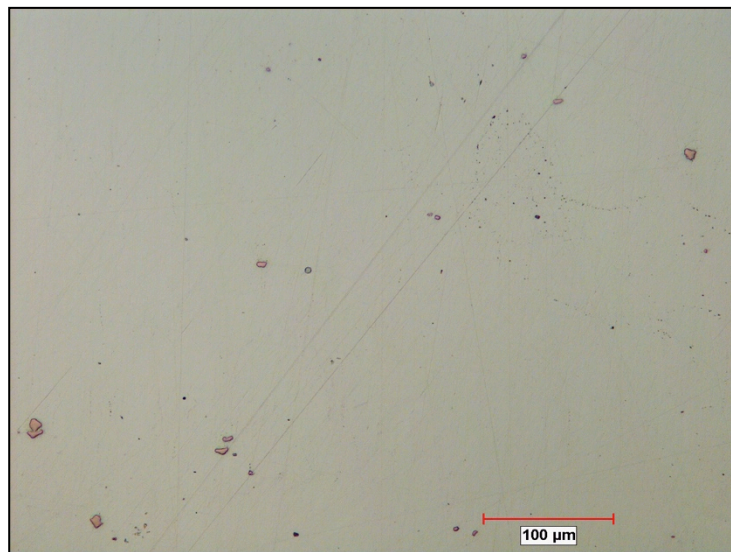
**Figure 2.3.1.6.** Improperly polished sample with clear surface scratches

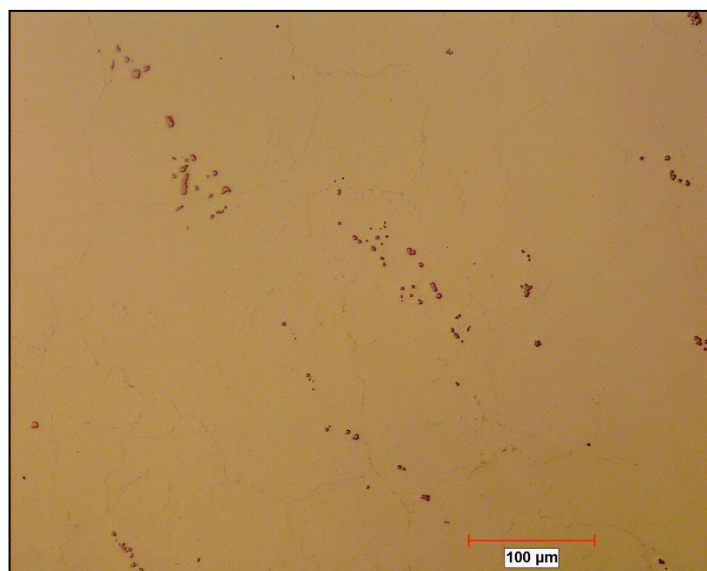
**Figure 2.3.1.7.** Under etched sample of Alloy 617

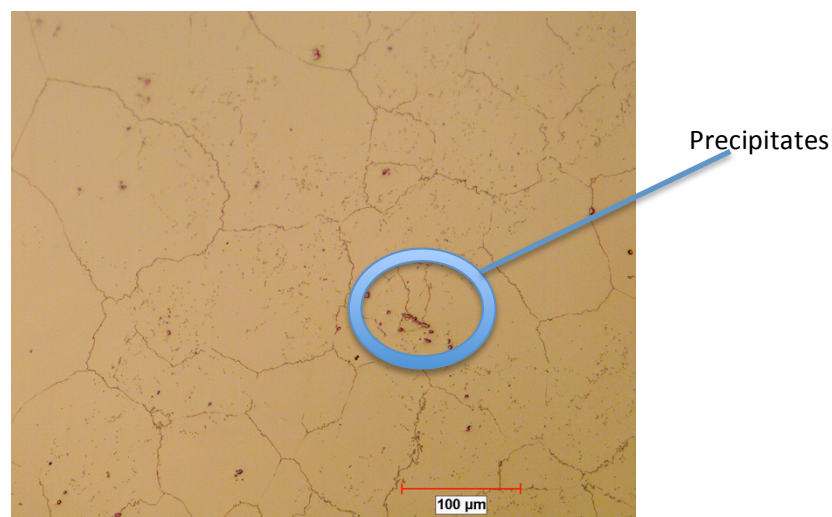
**Figure 2.3.1.10.** As-received Alloy 617

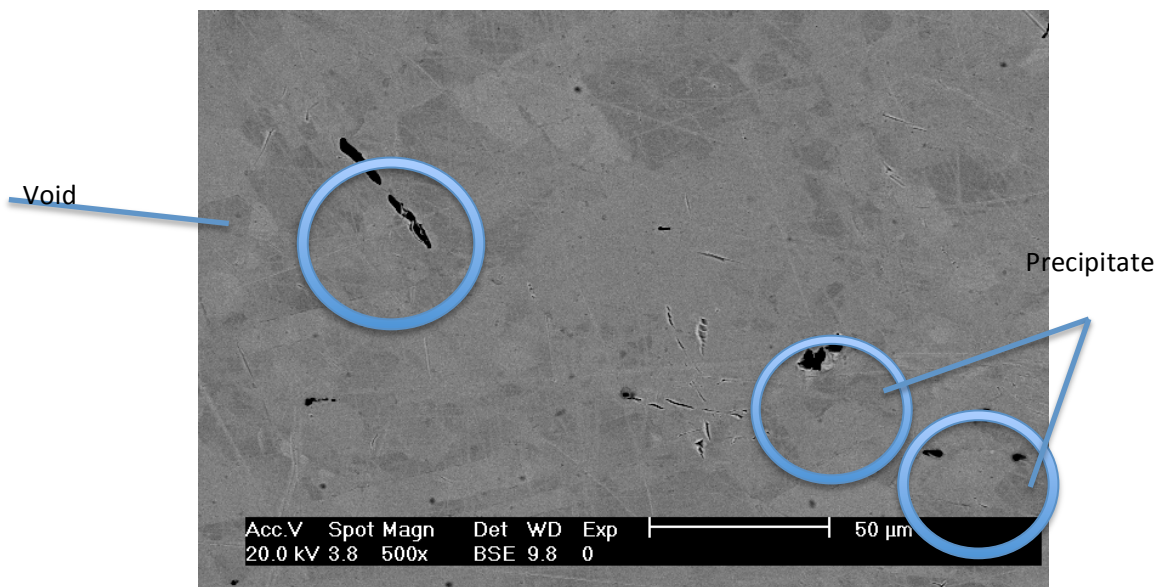
**Figure 2.3.1.13.** SEM image of creep tested Alloy 617 sample C02

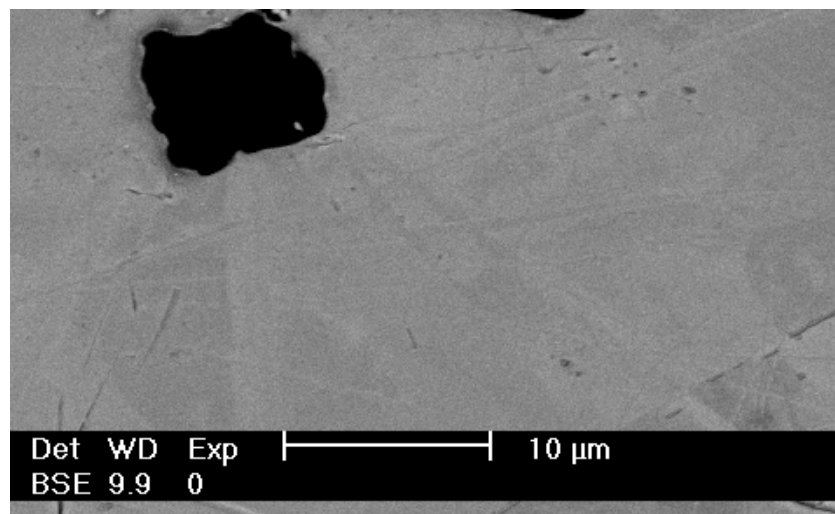
**Figure 2.3.1.14.** Precipitate in crept sample C02

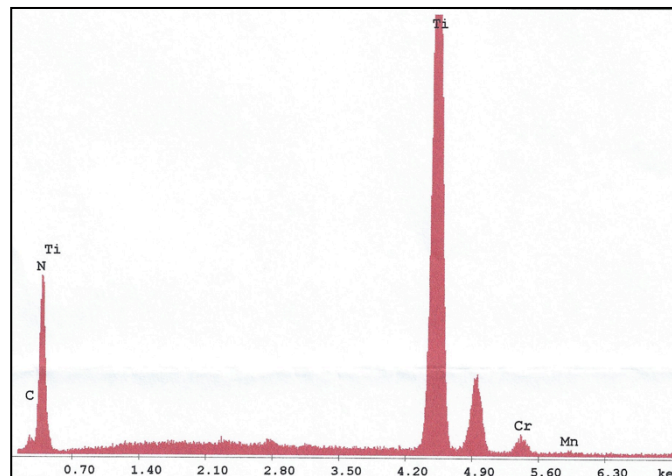
**Figure 2.3.1.15.** EDX results for larger size precipitate

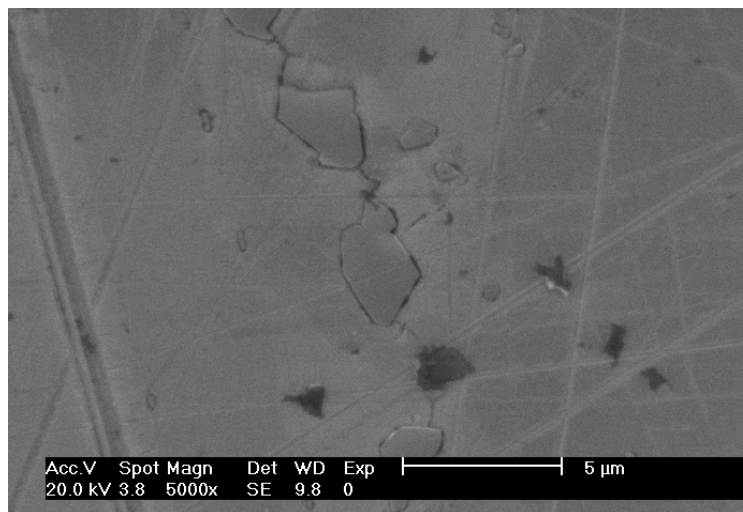
**Figure 2.3.1.16.** Smaller precipitates in crept sample C02

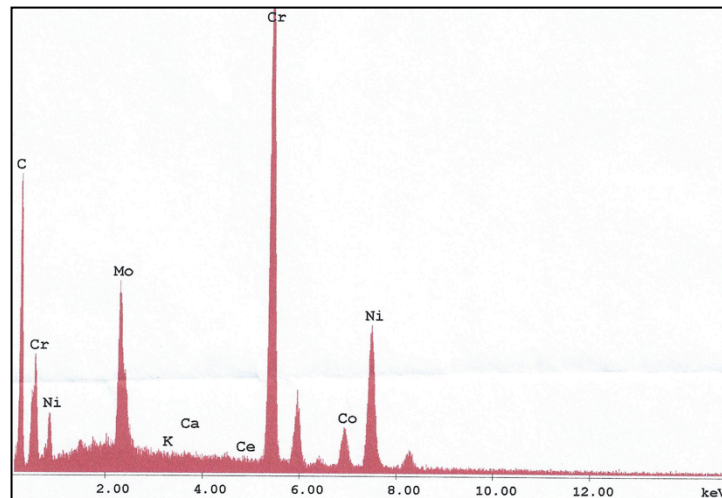
**Figure 2.3.1.17.** EDX results for smaller precipitates

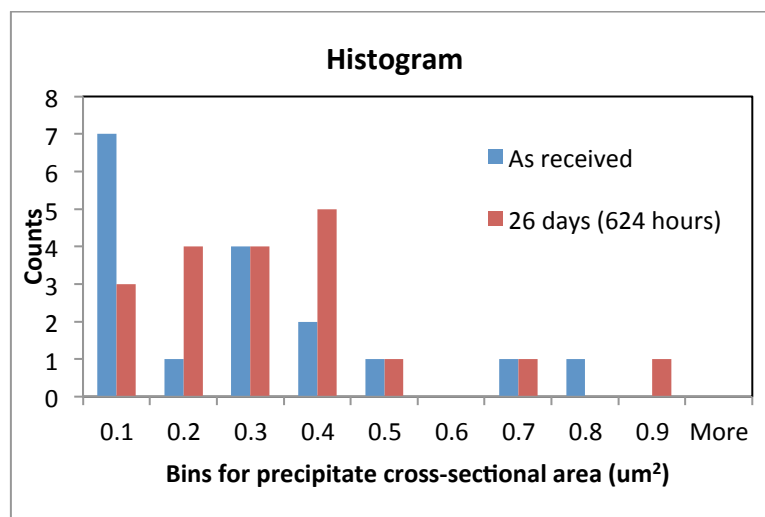
**Figure 2.3.3.3.** Histogram for measured cross sectional area of precipitates of T-0 and T-2

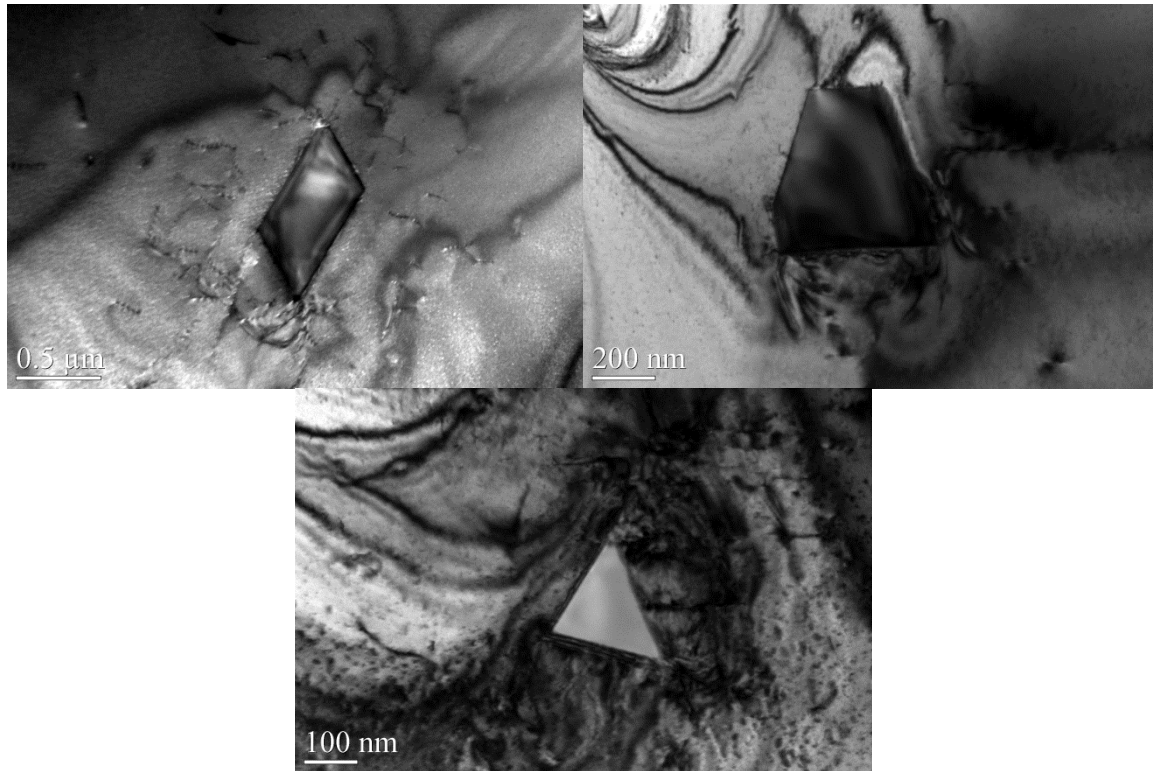
**Figure 2.3.3.4.** *Precipitates observed within T-0 (as received)*

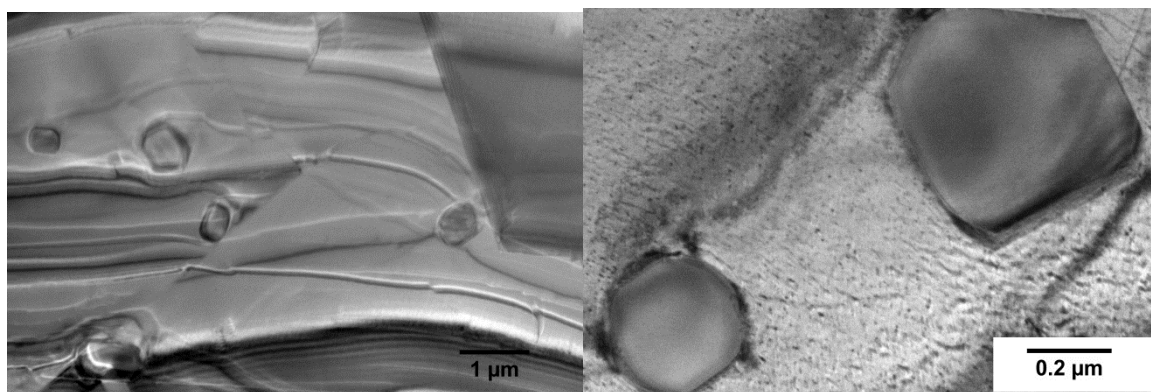
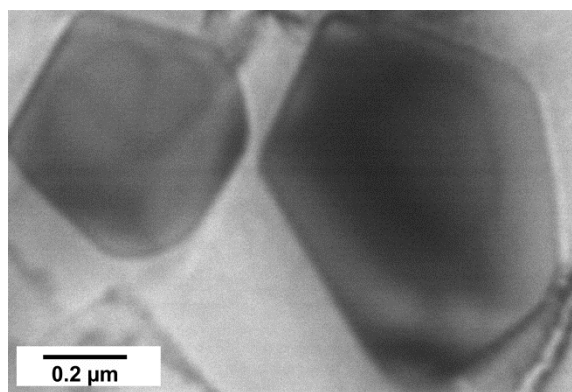
**Figure 2.3.3.5.** *Precipitates observed in sample T-2*

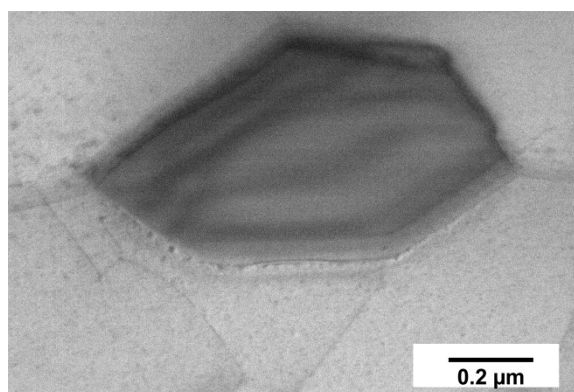
**Figure 2.3.3.6.** *Unusual precipitate from sample T-2*

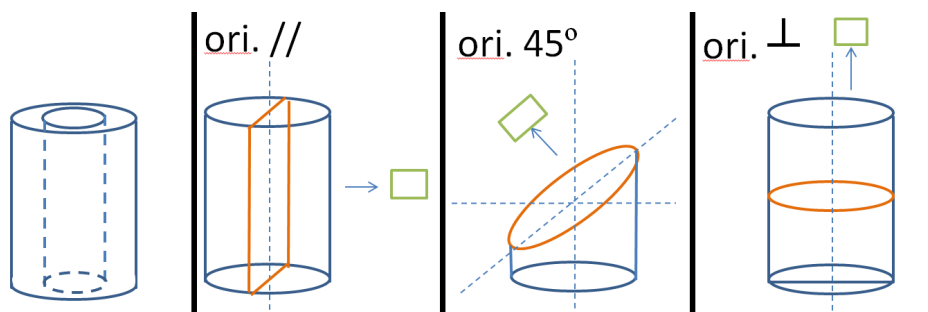
**Figure 2.3.3.1.** Sectioning of tubular specimen for TEM viewing. Sections were oriented parallel ( $//$  or  $0^\circ$ ), at 45 degrees ( $45^\circ$ ), and perpendicular ( $\perp$  or  $90^\circ$ ) to the generator axis of the cylindrical tube.

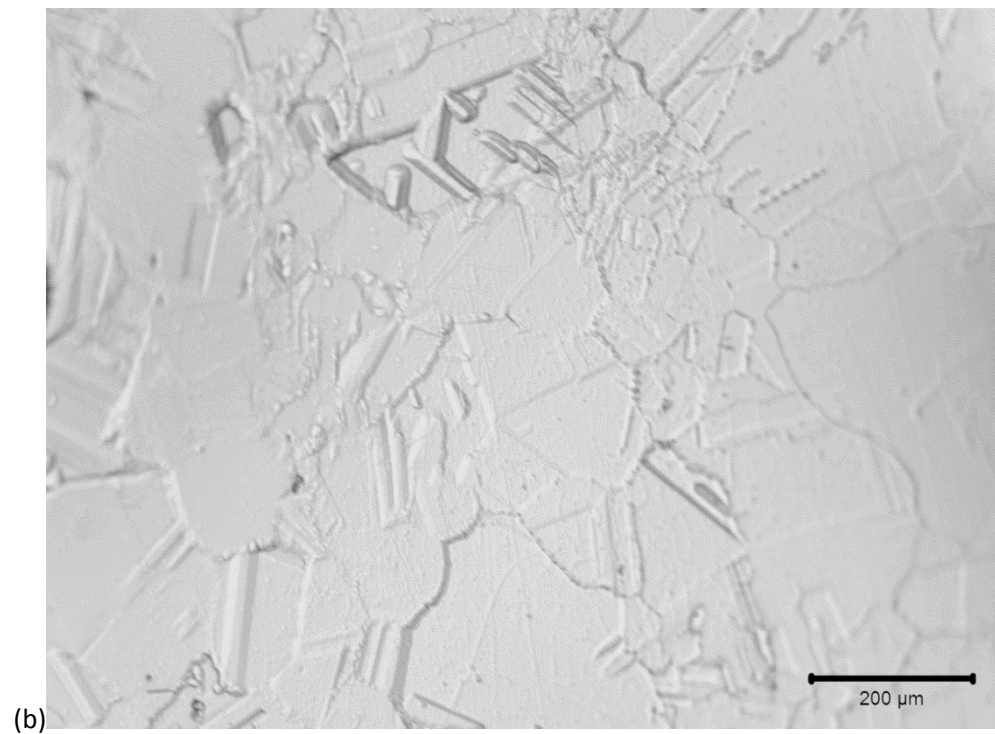
**Figure 2.3.3.2.** Ion milling of the TEM sample T-0 from the as-received material polished the surface and revealed grain boundaries; these images are from an optical microscope.

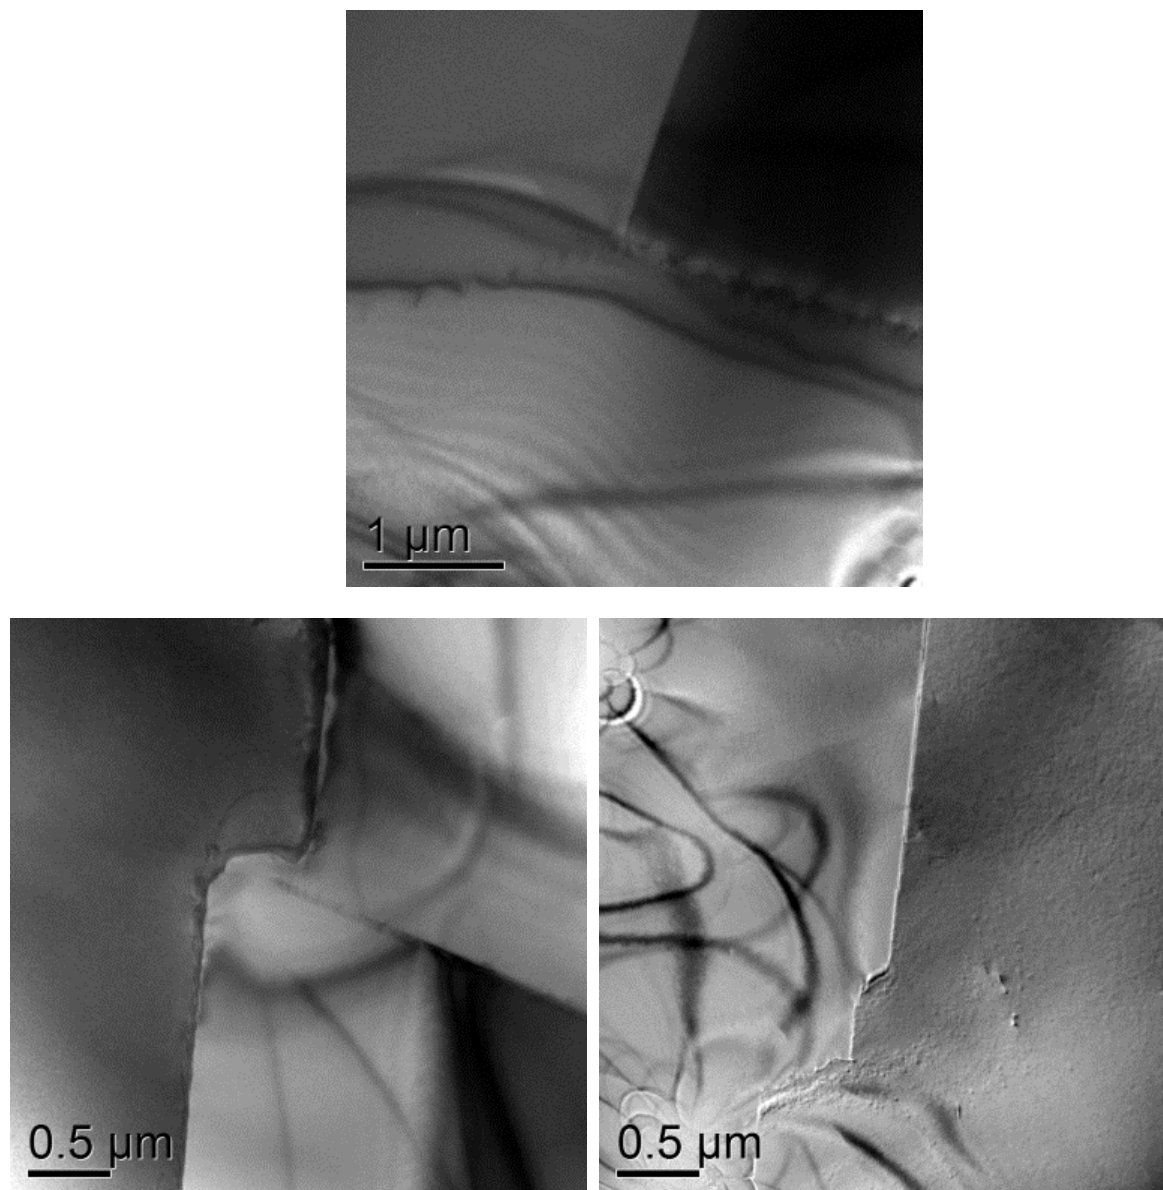
**Figure 2.3.3.3.** As-received T-0 sample views by TEM provide partial views of grain boundaries with very small dislocation densities and thickness fringes (thicker dark bands).

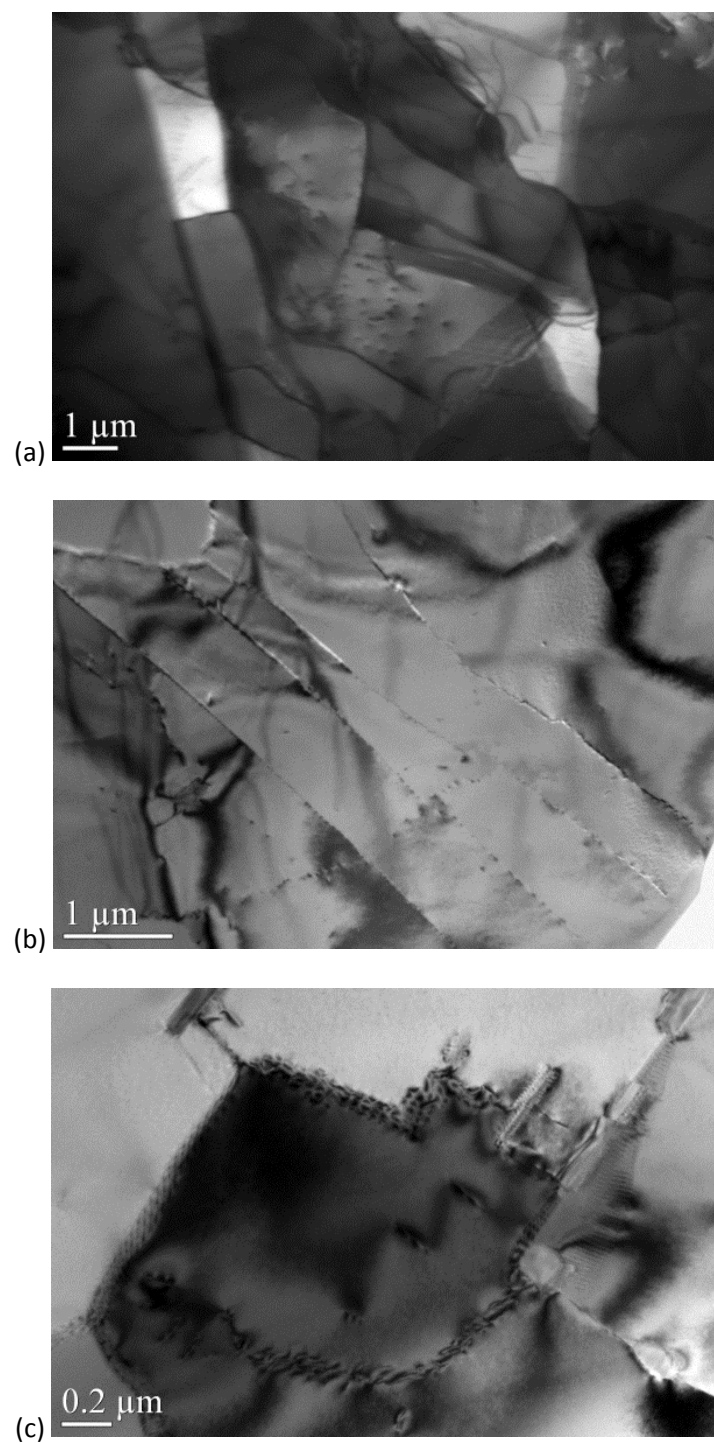
**Figure 2.3.3.4.** TEM sample images from specimen 617-3 viewed at 0°; smaller grains and dislocation networks at grain boundaries are evident.

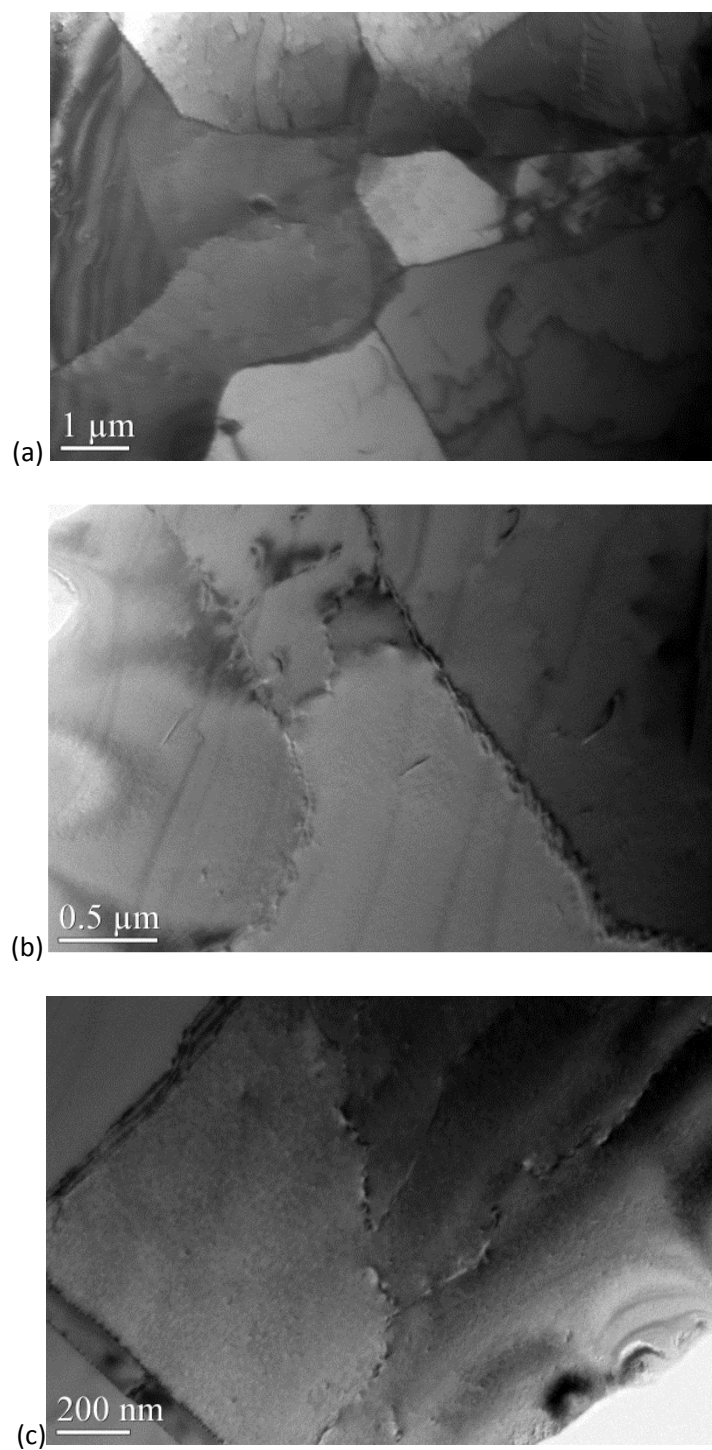
**Figure 2.3.3.6.** TEM sample images from specimen 617-3 viewed at 90°; smaller grains and dislocation networks at grain boundaries are evident.

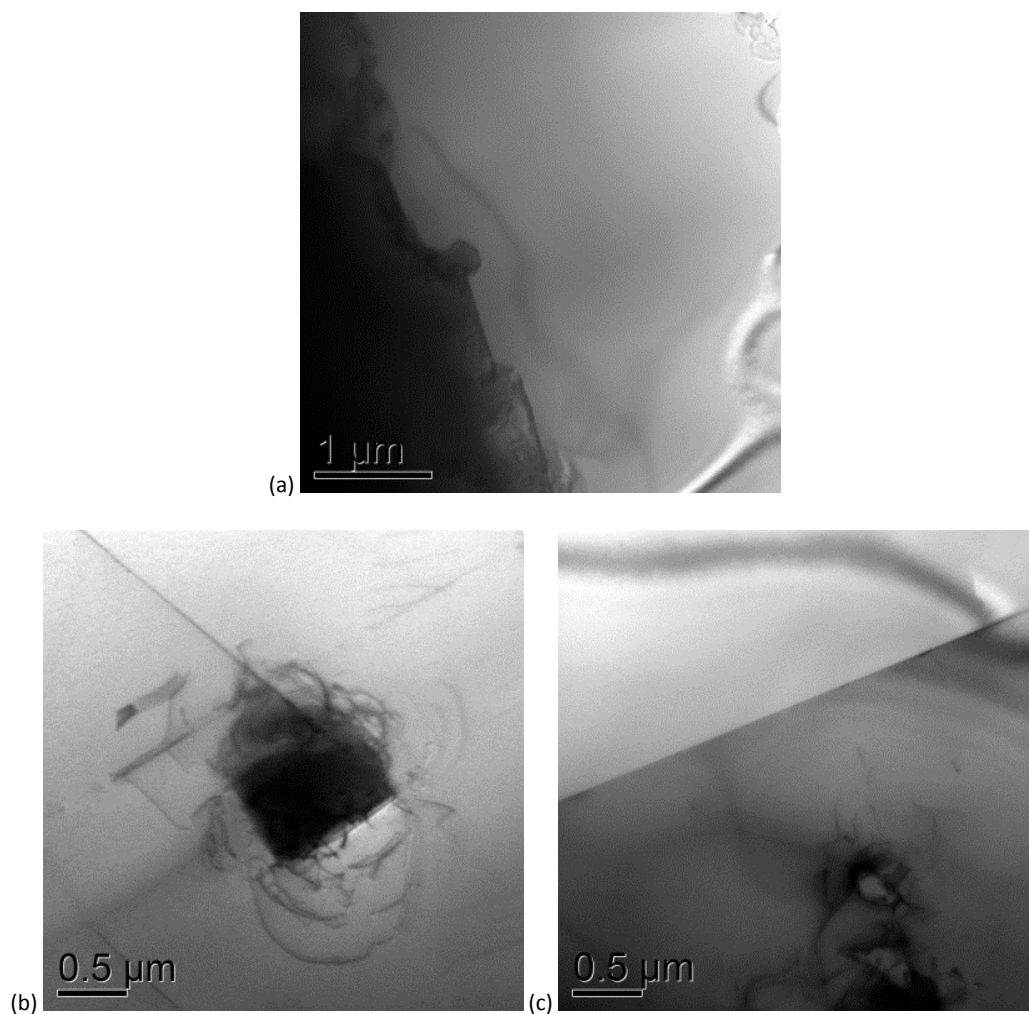
**Figure 2.3.3.7.** As-received T-0 TEM images of isolated precipitates with a small surrounding region of dislocations; viewed with JOEL 2010F TEM/STEM.

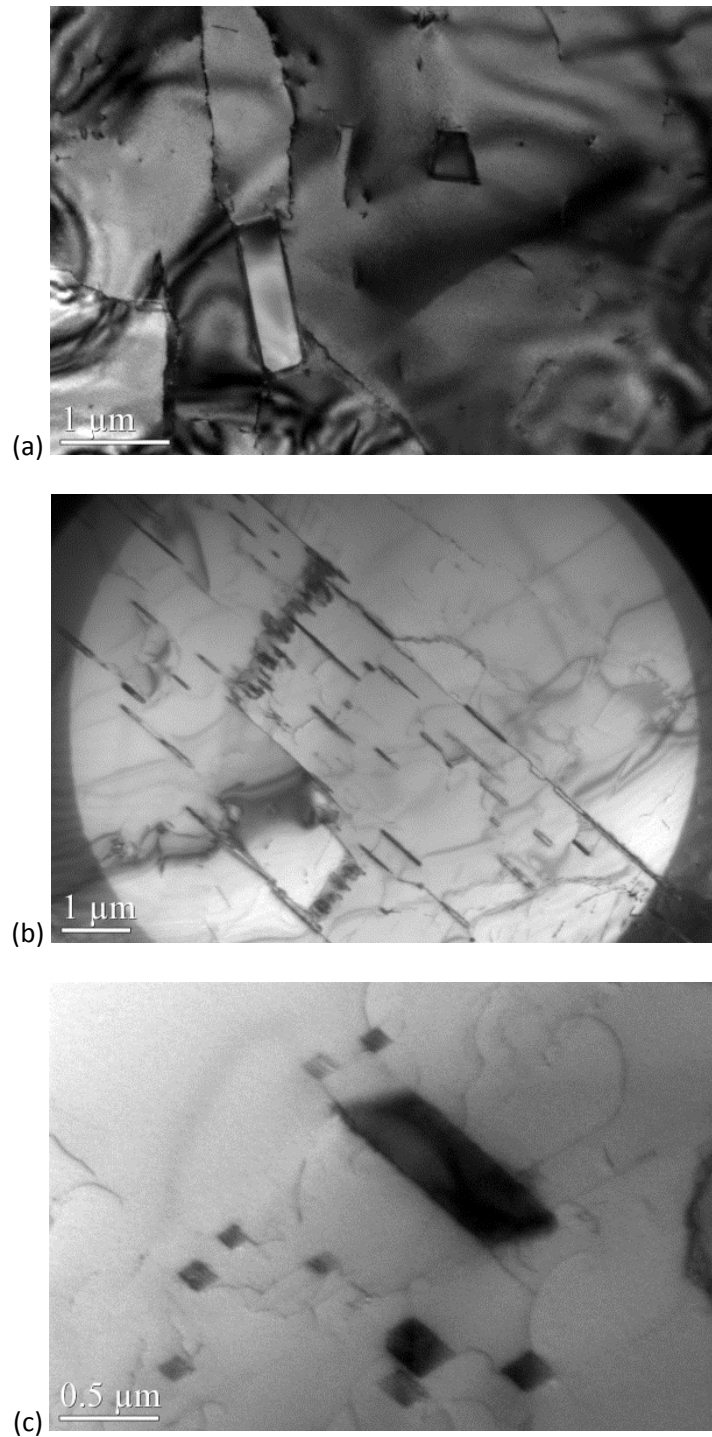
**Figure 2.3.3.10.** TEM images from (a) 45° and (b and c) 90° samples from specimen 617-3 show isolated precipitates and clusters of precipitates with nearby dislocations; viewed with JEOL 2010 LaB6.
